## MARINE INVESTIGATION REPORT

M99W0095

CAPSIZING WITH LOSS OF LIFE

*MARABELL 8*

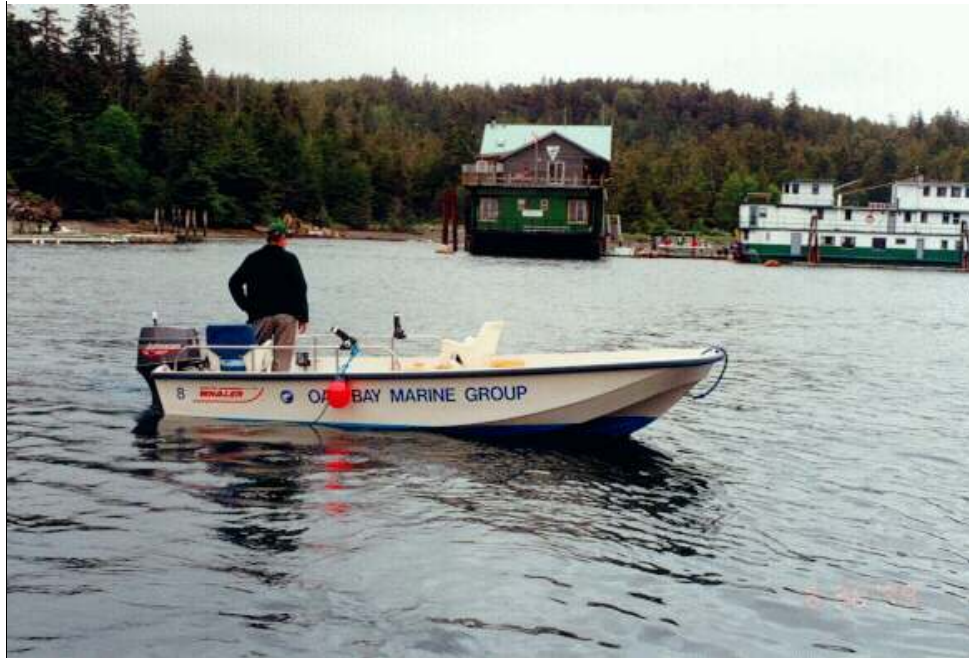
Photo 1. *Marabell 8* in Henslung Cove, Langara Island, British Columbia, on 30 June 1999

- The VHF transceiver sustained seawater damage.
- The swivel chair, located amidships on the starboard side, and two plastic portable fuel tanks were missing.
- The left side of a horizontally mounted aluminum bracket attached to the outboard motor was bent upward. (The bracket was part of a mechanism used to maintain a steady course while trolling for salmon.)
